Ryobi P202 Magnetic Tray Replacement

Replacement guide for the magnetic storage tray.

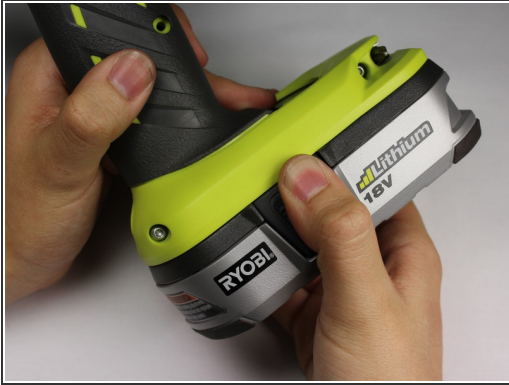
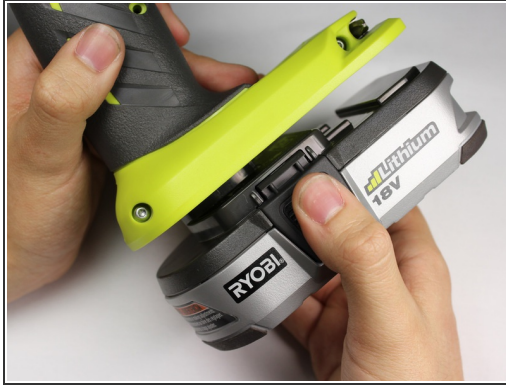
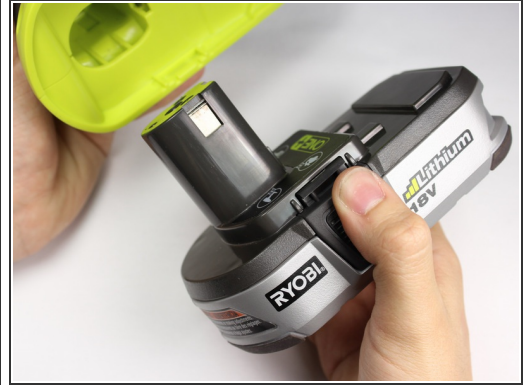
Step 1 — Battery

- Detach the battery unit from the drill body by pressing the battery release buttons on both sides of the unit and pulling outwards.

The battery can shock you. Only touch plastic, non-conductive components.

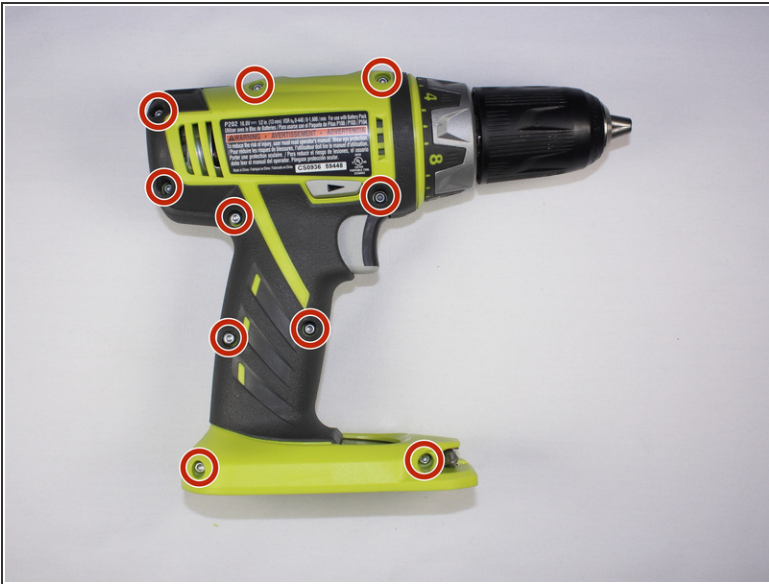
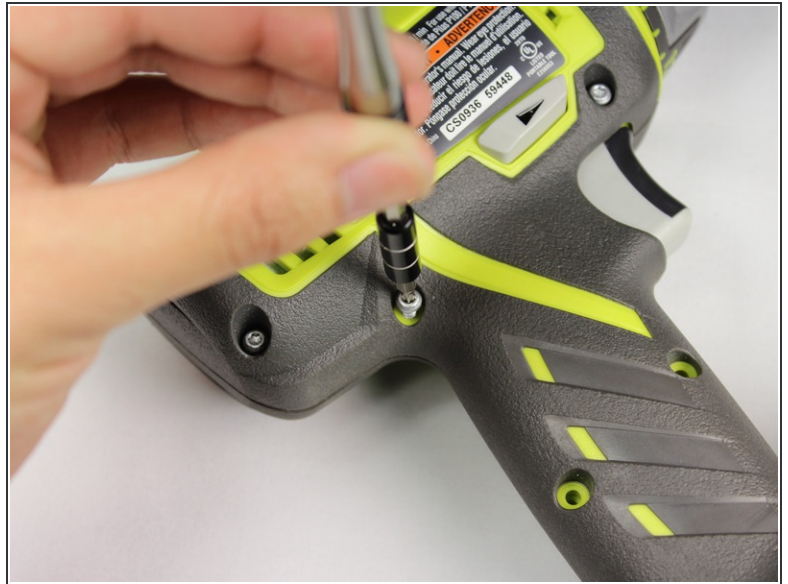
Step 2 — Right Side Case

- Use a Torx T10 screw driver to unscrew all ten 13.5 mm screws from the drill casing to gain access to the interior.

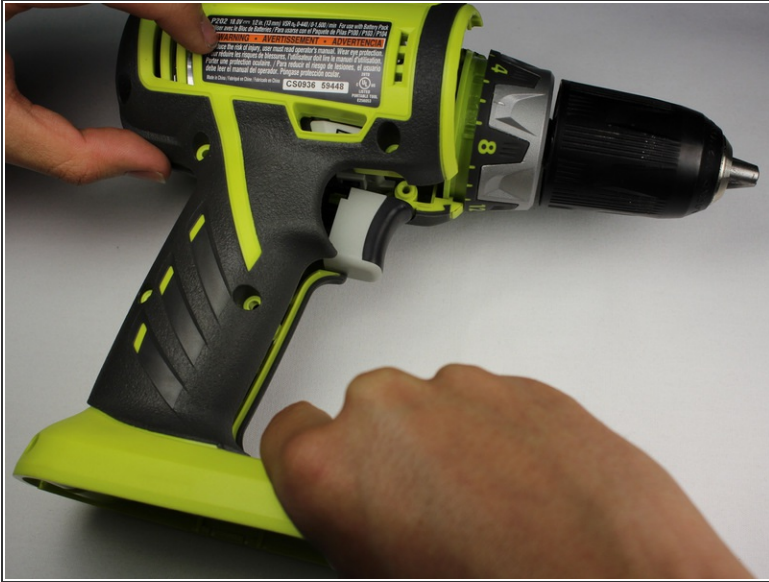
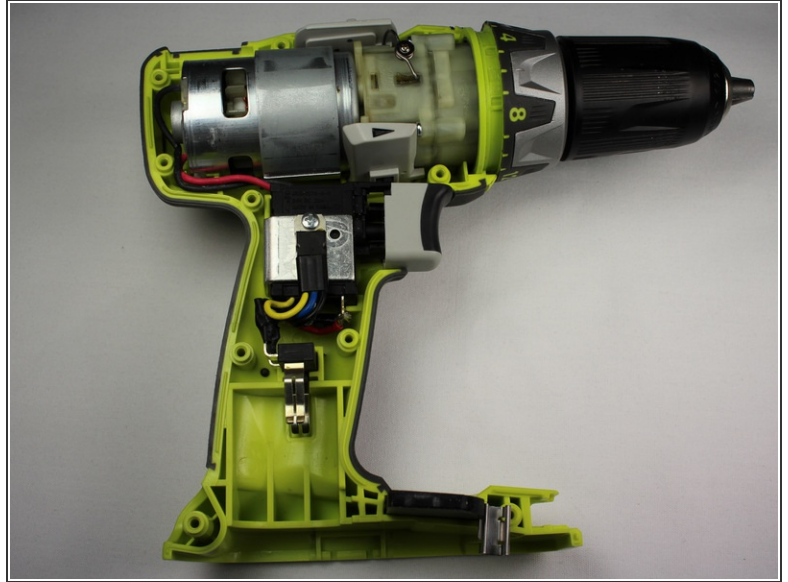
Step 3

- Gently lift the casing from the drill body.
- Take the casing completely off the drill body to gain access to the interior of the drill.

The Ryobi P202 casing has Part #: 200690001

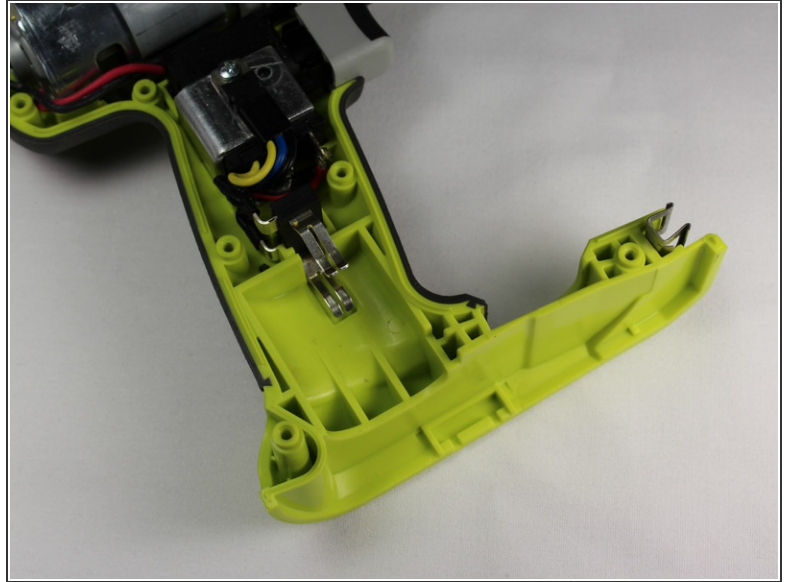
Step 4 — Magnetic Tray

- Gently lift the magnetic tray from the bottom of the drill body.

The magnet is Part #: 303001015

To reassemble your device, follow these instructions in reverse order.
